**Flood Control Project Maintenance
Levee Inspections**

Fall 2010 Levee Maintenance Deficiency Summary Report

San Joaquin River Basin

Reclamation District No. 2075 McMullin

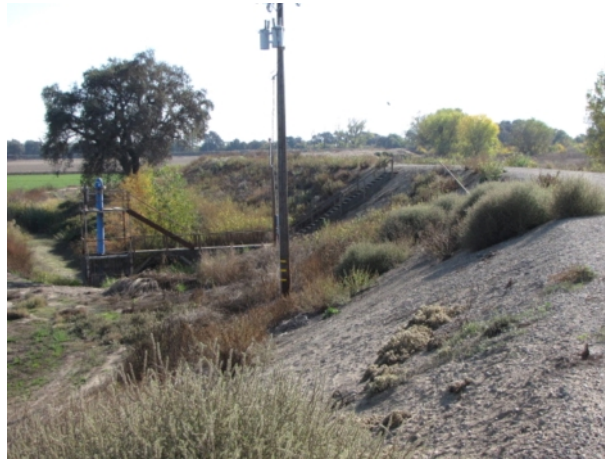
Levee Mile Report Line	1
Start Levee Mile	0.09
End Levee Mile	0.09
Location	Water Side
Category	Earthen Levee
Item	Vegetation

RD 2075 looking downstream from leve mile 0.09
landside slope, slopes has been sprayed by
District.. 11-12-2010

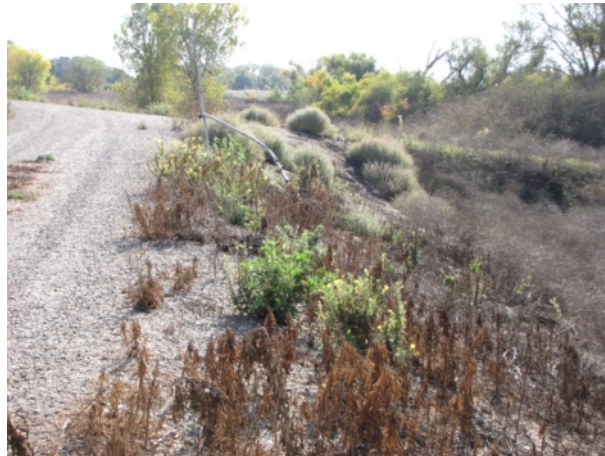
Levee Mile Report Line	2
Start Levee Mile	0.09
End Levee Mile	0.09
Location	Water Side
Category	Earthen Levee
Item	Vegetation

Water side RD 2075 looking downstream of levee
mile 0.09 11-12-2010

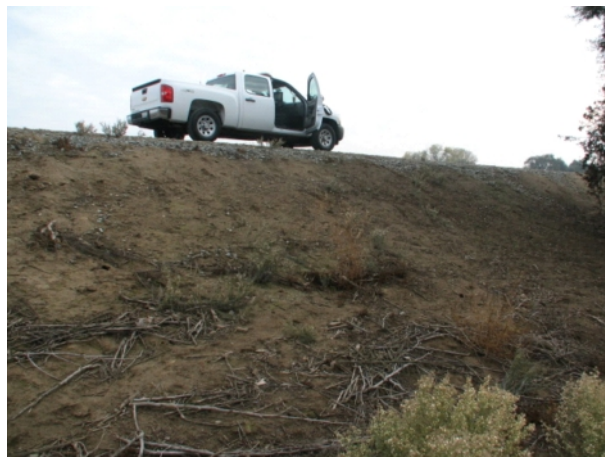
Levee Mile Report Line	3
Start Levee Mile	0.92
End Levee Mile	0.92
Location	Water Side
Category	Earthen Levee
Item	Crown Surface / Depressions / Rutting

Photo taken from waterside during 12/2/2010
reinspection. Repairs made to depressions on
levee slope.

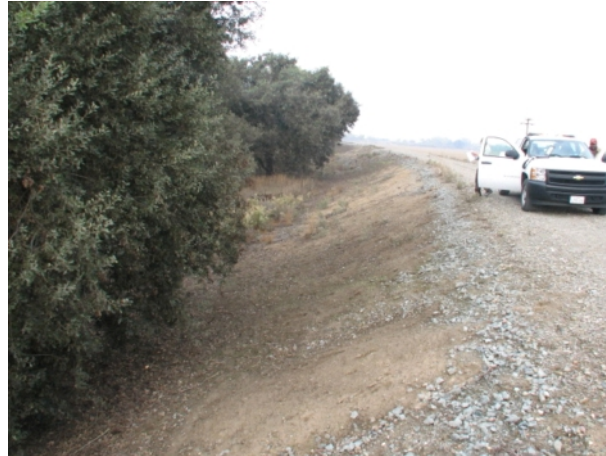
Levee Mile Report Line	3
Start Levee Mile	0.92
End Levee Mile	0.92
Location	Water Side
Category	Earthen Levee
Item	Crown Surface / Depressions / Rutting
Additional photo taken during 12/2/10 reinspection from crown looking downstream.	
jpaasch_f_20101206_308.jpg

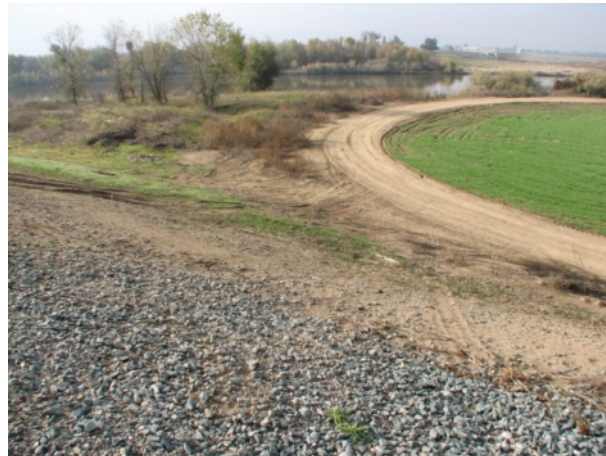
Levee Mile Report Line	10
Start Levee Mile	2.73
End Levee Mile	2.73
Location	Water Side
Category	Earthen Levee
Item	Crown Surface / Depressions / Rutting
Photo taken from crown looking down waterside slope during 12/2/2010 reinspection. Repairs were made to depressions on levee slope as indicated in KSN letter. Since then, vehicular traffic has created new ruts in repaired area approximately 1 to 6 inches in depth.	
jpaasch_f_20101206_309.jpg

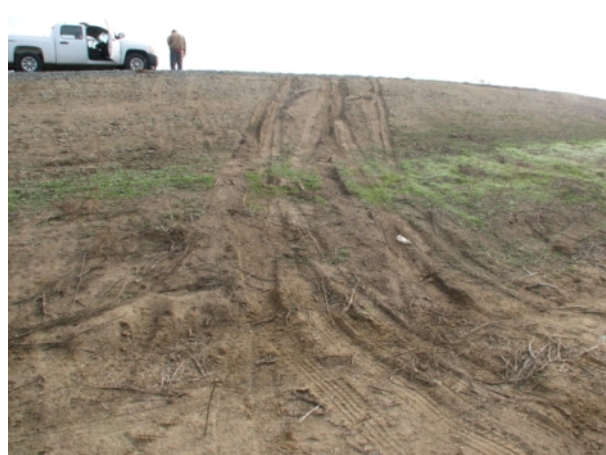
Levee Mile Report Line	10
Start Levee Mile	2.73
End Levee Mile	2.73
Location	Water Side
Category	Earthen Levee
Item	Crown Surface / Depressions / Rutting
Photo taken during 12/2/10 reinspection from the waterside. Depressions from vehicle traffic made in previously repaired area.	
jpaasch_f_20101206_310.jpg

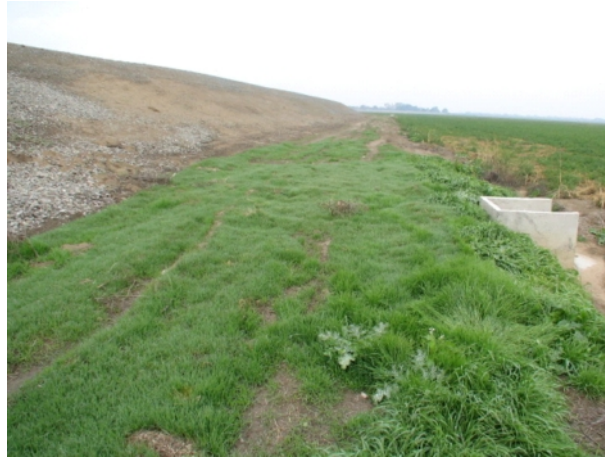
Levee Mile Report Line	11
Start Levee Mile	2.91
End Levee Mile	2.91
Location	Land Side
Category	Earthen Levee
Item	Crown Surface / Depressions / Rutting

11	2.91	2.91	Earthen Levee	Crown Surface / Depressions / Rutting	LS	A	Inspector Comments: This item was identified with an Unacceptable rating in the USACE PI report for the San Joaquin River East Levee System (MCMU_2009_a_0107). Reinspecton on 12/2/10 revealed that repairs were made as indicated in the 11/8/10 letter from KSN.	37.724037 ° -121.292593 °	37.724037 ° -121.292593 °	20 Y
12	3.32	3.32	Earthen Levee	Crown Surface / Depressions / Rutting	LS	A	Inspector Comments: This item was identified with an Unacceptable rating in the USACE PI report for the San Joaquin River East Levee System (MCMU_2009_a_0102). Reinspecton on 12/2/10 revealed that repairs were made as indicated in the 11/8/10 letter from KSN.	37.719437 ° -121.287863 °	37.719437 ° -121.287863 °	19 Y

Photo taken during 12/2/10 reinspection from the landside toe looking downstream. Depression has been repaired and area has been graded to drain into tailwater collection system.

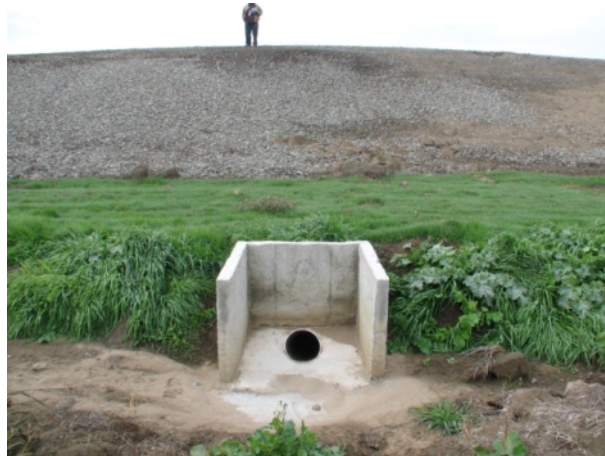
Levee Mile Report Line	11
Start Levee Mile	2.91
End Levee Mile	2.91
Location	Land Side
Category	Earthen Levee
Item	Crown Surface / Depressions / Rutting

Photo taken on landside looking toward levee. Area has been graded to drain into collection system. Depression has been repaired.

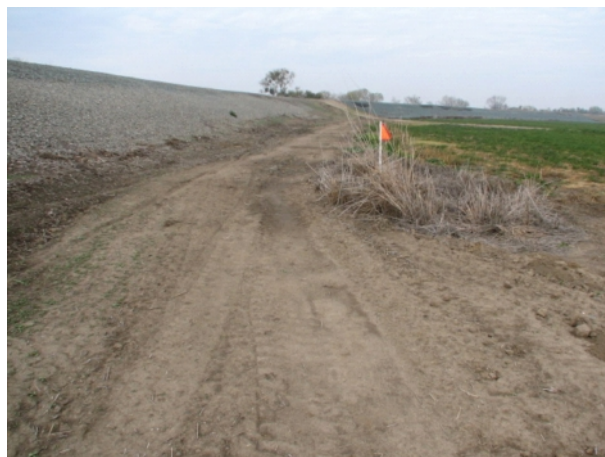
Levee Mile Report Line	12
Start Levee Mile	3.32
End Levee Mile	3.32
Location	Land Side
Category	Earthen Levee
Item	Crown Surface / Depressions / Rutting

Photo taken from landside toe looking downstream during 12/2/2010 reinspection. Repairs were made to depression off of the levee toe as indicated in KSN letter. Area graded to drain to tailwater collection system.

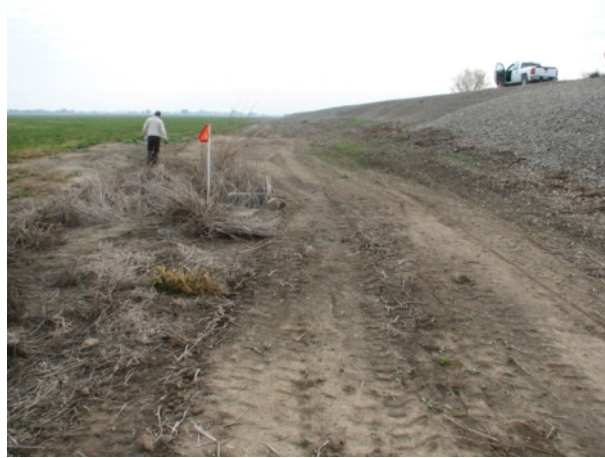
Levee Mile Report Line	12
Start Levee Mile	3.32
End Levee Mile	3.32
Location	Land Side
Category	Earthen Levee
Item	Crown Surface / Depressions / Rutting

Photo taken from levee toe looking upstream at repaired depression. Depression was located between the drainage inlet and the levee toe.

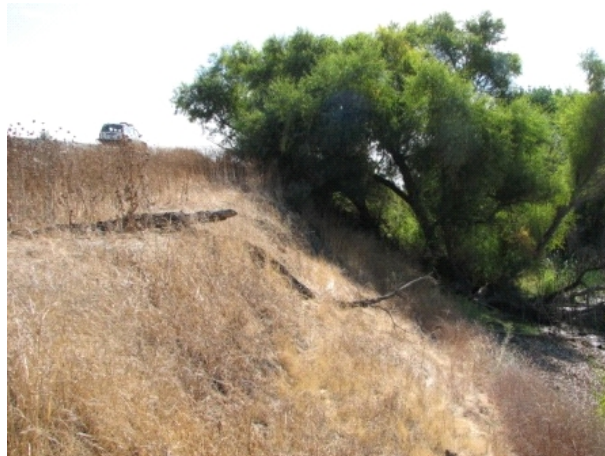
Levee Mile Report Line	14
Start Levee Mile	5.34
End Levee Mile	5.35
Location	Water Side
Category	Supplemental
Item	DWR Erosion Survey

Looking upstream of site towards the levee crown.

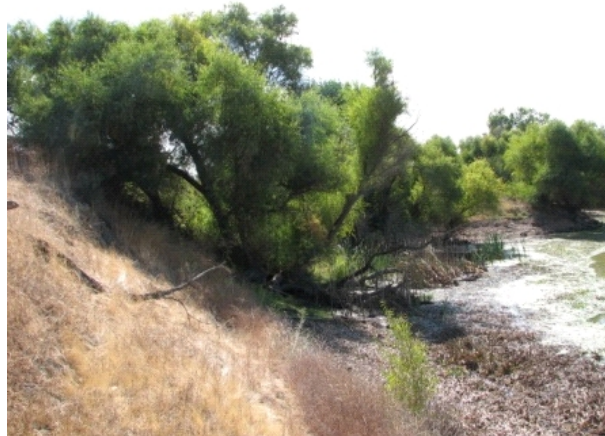
Levee Mile Report Line	14
Start Levee Mile	5.34
End Levee Mile	5.35
Location	Water Side
Category	Supplemental
Item	DWR Erosion Survey

Looking upstream of site at the leaning tree.

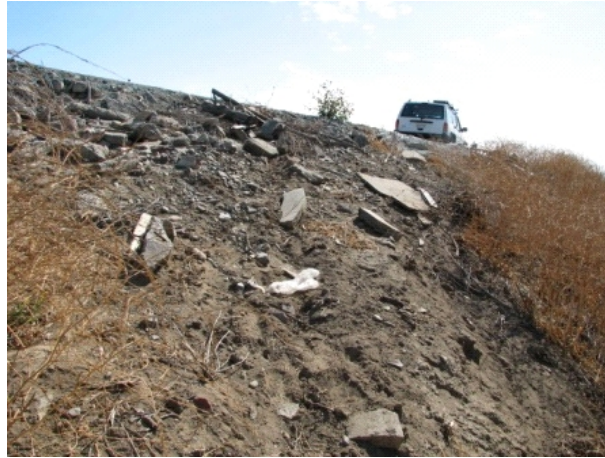
Levee Mile Report Line	14
Start Levee Mile	5.34
End Levee Mile	5.35
Location	Water Side
Category	Supplemental
Item	DWR Erosion Survey

Looking upstream of site towards the levee crown.

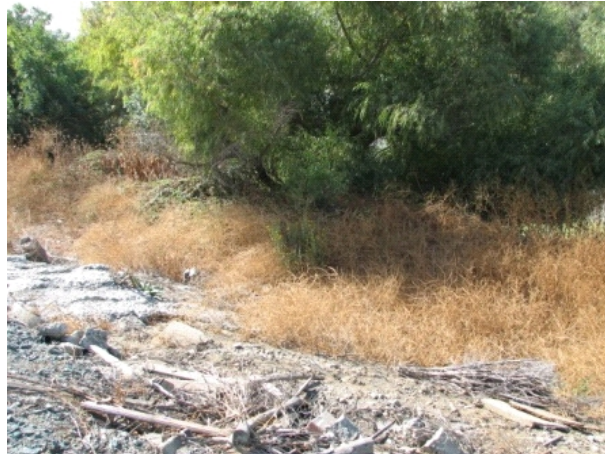
Levee Mile Report Line	14
Start Levee Mile	5.34
End Levee Mile	5.35
Location	Water Side
Category	Supplemental
Item	DWR Erosion Survey

View of the affected tree from the levee crown.
